Recreational Use Attainability Analysis of Five Creeks along the Little Brazos River: Walnut Creek (1242O), Mud Creek (1242K), Pin Oak Creek (1242L), Spring Creek (1242M), and Campbells Creek (1242I)

Prepared for:
Texas State Soil and Water Conservation Board
Project 08-54

Data Collected by:
Brazos River Authority

June 2014

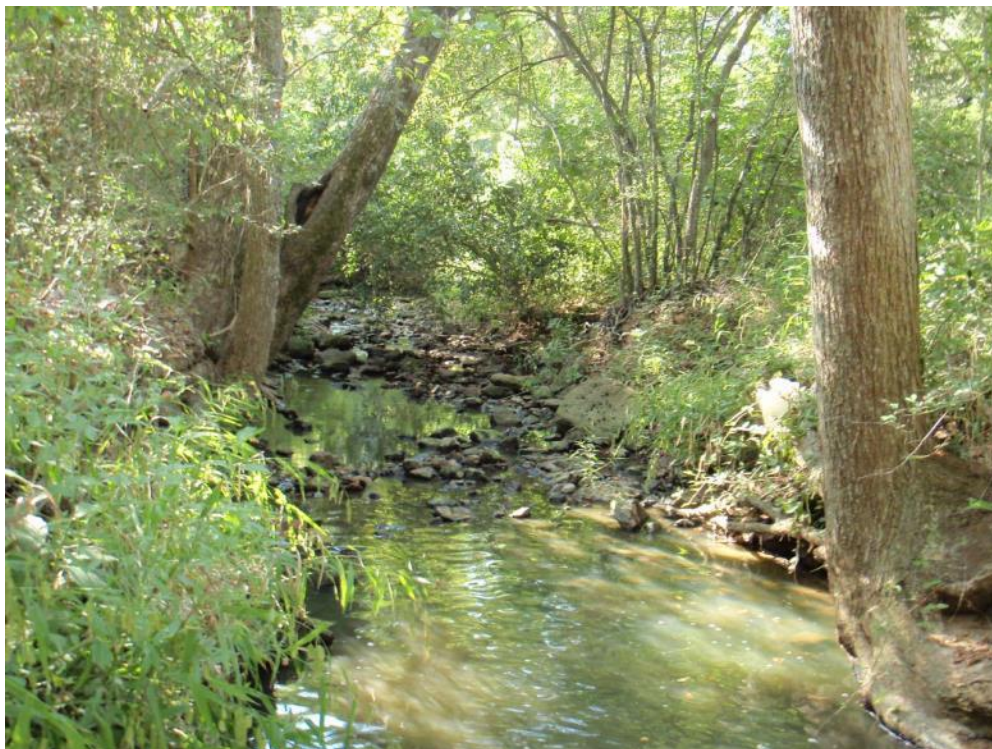
Figure 5.10 Photograph of Mud Creek Site 99907 taken on August 27, 2010, the upstream view of the 300-m transect.

Mud Creek at Site 99907 was visited on June 23 and August 27, 2010. This site is located on State Highway 79 approximately 1 mile west of Franklin, Texas, and 5.9 miles upstream of Site 20562. The site is located downstream of the City of Franklin WWTP discharge. Site 99907 was accessible at the area immediately underneath the bridge crossing; however, the stream was fenced off immediately downstream of the bridge crossing. Accessibility to the stream was moderately easy due to the mowed State Highway 79 right-of-way. Log jams within the stream channel and thick vegetation along the banks were encountered during both surveys. Figures 5.9 and 5.10 depict the appearance of the site during each of the surveys. Average thalweg depth was 0.31 meters during the June event and 0.27 meters during the August event. Five pools were identified during the June survey and one was identified during the August survey, all with depths less than 1 meter (Tables 5.17 and 5.18).

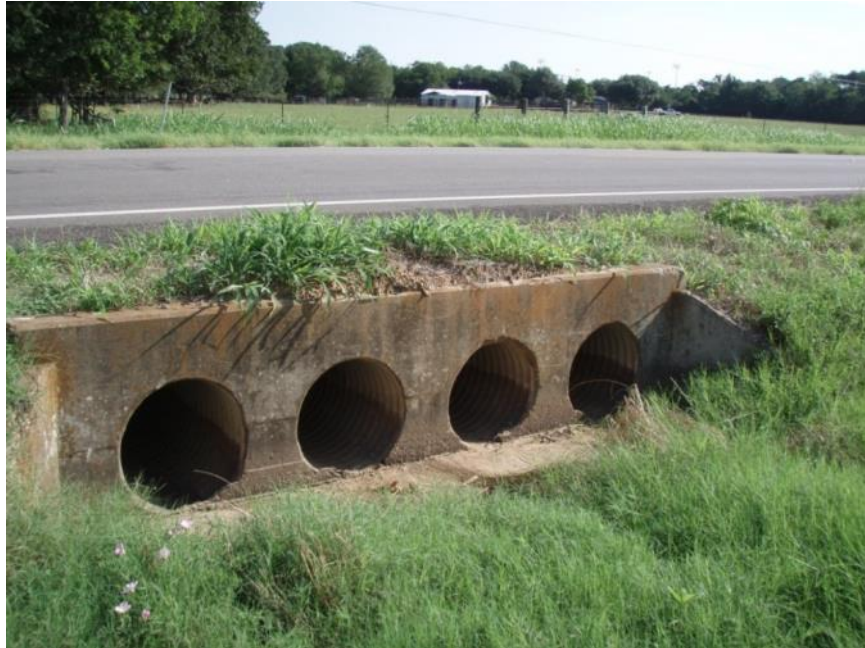
Figure 5.11 Photograph of Mud Creek Site 99908 taken on June 23, 2010, the upstream view from FM 1644.

Mud Creek at Site 99908 was visited on June 23 and August 24, 2010. This site is located on Mud Creek at RM 1644 (also known as Dechard Street) approximately 0.70 miles west of Franklin, Texas and just upstream of the City of Franklin WWTF discharge. Franklin High School and athletic complex are located approximately 350 m west of this site. Accessibility to the stream was moderately easy at the area immediately adjacent to the road crossing; however, fences on the upstream and downstream side of the bridge crossing prohibited access past the boundaries of the FM 1644 right-of-way, so observations were made only from the FM 1644 crossing. This headwaters portion of Mud Creek may be characterized as a slight depression with no distinguishable channel in a cattle pasture. This portion of Mud Creek was completely dry at the time of the surveys. Figures 5.11 and 5.12 depict the appearance of the site during each of the surveys.

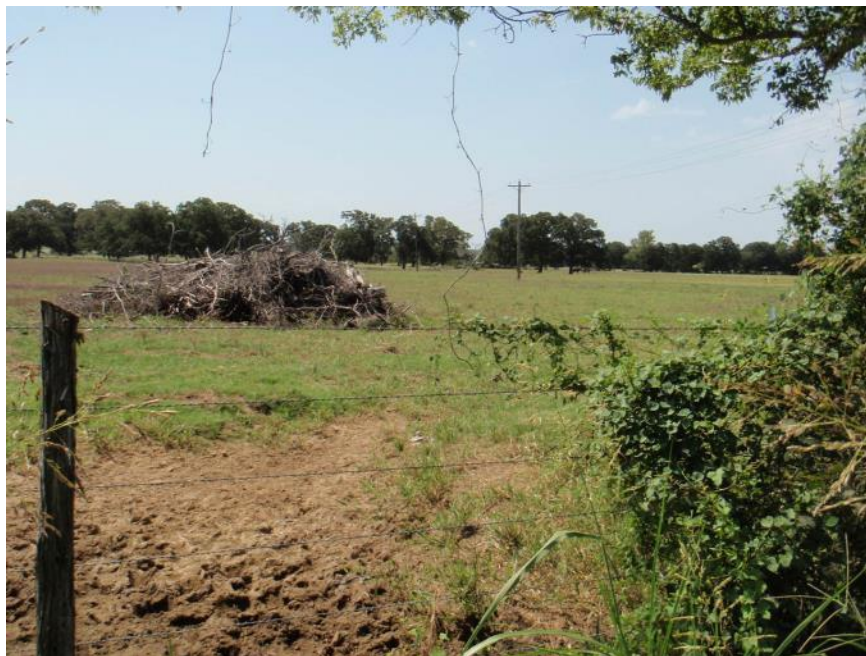
Figure 5.12 Photograph of Mud Creek Site 99908 taken on August 24, 2010, the upstream view from FM 1644.

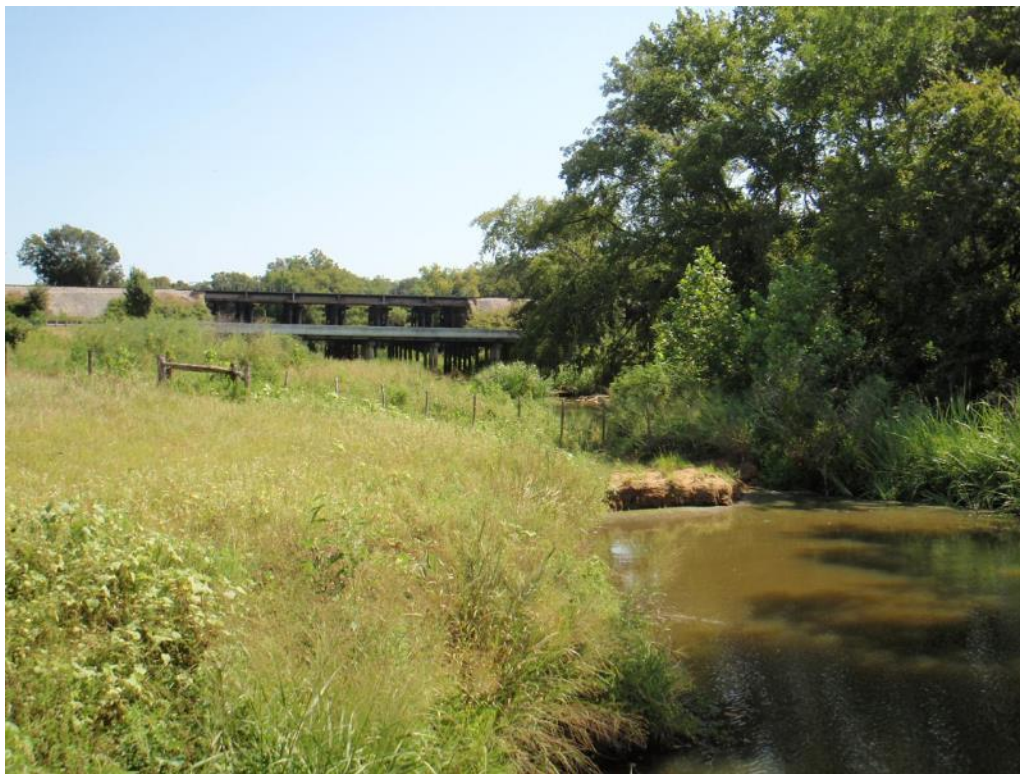
Figure 6.2 Photograph of Pin Oak Creek Site 16401 taken on August 23, 2010, the upstream view of the 30-m transect, including deep pool.

Pin Oak Creek at Site 16401 was visited on August 9 and 23, 2010. Located southeast of Hearne, Texas, in Robertson County, this site was accessible from the right-of-way of SH 6 / US 190, but was located primarily in a private pasture with a locked gate and a “no trespass” sign. The western (right bank) riparian zone was dominated by pasture up to the water’s edge, whereas the eastern (left) bank was largely trees and shrubs several meters to > 20 m back from the stream. Access to the stream was easy, particularly on the pastured, gently sloping right bank. Figures 6.2 and 6.3 depict the general appearance of the site and water quality during each of the surveys.

The two surveys at Site 16401 were conducted only two weeks apart and conditions did not change significantly in that span. Stream widths ranged from 0.0 to 18.0 m with a typical width of 5 m (Tables 6.8 and 6.9). Average thalweg depth was 0.69 ft during both surveys (Table 6.9), but the stream was non-wadeable due to several deep pools greater than 1.2 m deep (Tables 6.12 and 6.13; Figure 6.2). The stream channel was difficult to wade even when not in the pools, because of the sludge substrate. Figures 6.2 and 6.3 illustrate the brown to black water color witnessed during both surveys (Tables 6.10 and 6.11).

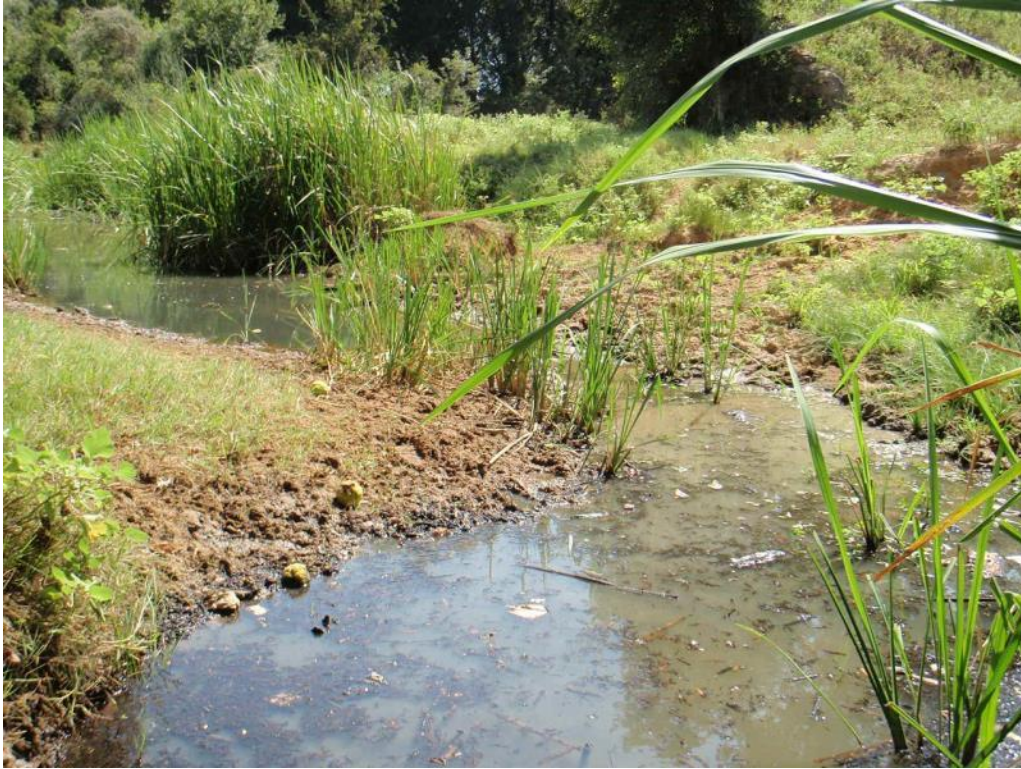
Figure 6.3 Photograph of Pin Oak Creek Site 16401 taken on August 23, 2010, the upstream view of the 300-m transect with debris on the brown-black water.

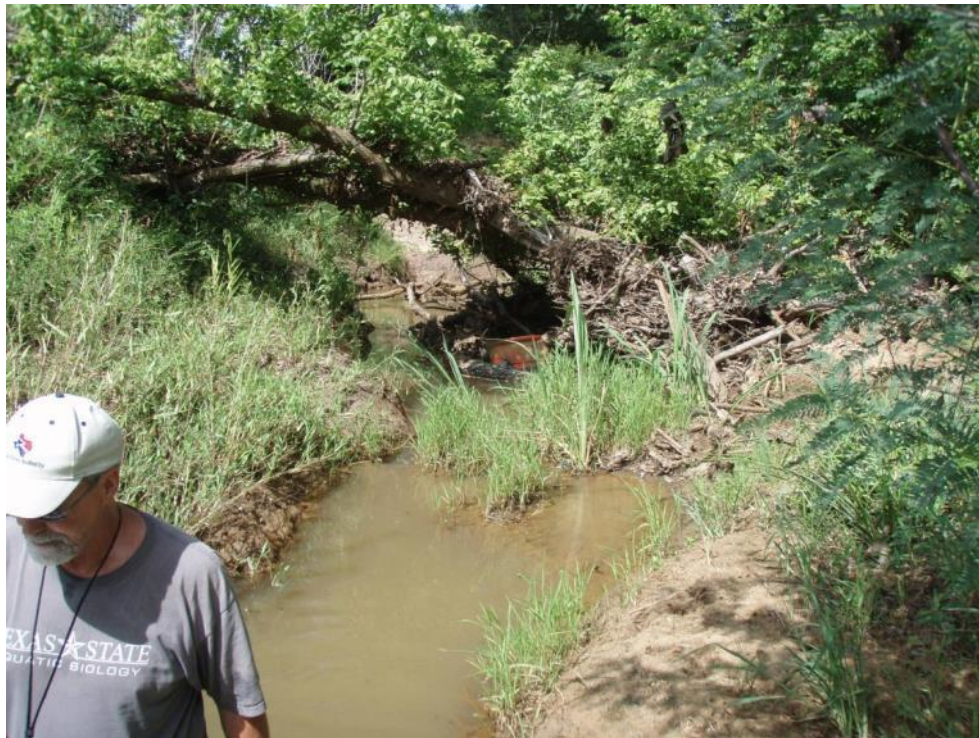
Figure 6.4 Photograph of Pin Oak Creek Site 20385 taken on June 29, 2010, the downstream view of the 30-m transect including felled tree. BRA personnel in photograph.

Pin Oak Creek at Site 20385 was visited on June 29 and August 23, 2010. Located east of Hearne, Texas, in Robertson County, this site was accessible from the right-of-way of FM 2549. No fences restricted public access but the majority of the 300-m reach was on private land. The eastern riparian south of the FM 2549 had a narrower zone of forest (approximately < 10 m) compared to the western riparian (approximately 20 m). Both sides of the stream corridor beyond the riparian zone were primarily pasture. The stream was moderately easy to access due to gently-sloping banks in some locations and the absence of private property fences (Table 6.7). There were more steep and treacherous banks in other locations throughout the reach. Figures 6.4 and 6.5 depict the appearance of the site during each of the surveys.

Site 20385 was wadeable for the entire 300-m reach length with occasional log jams and a felled tree acting as moderate obstacles (Figure 6.4). Several pools were present during both surveys, but none of them exceeded 1.0 m in depth (Tables 7.14 and 7.15). Average thalweg depth decreased from 0.32 m during the first survey to 0.27 m during the second survey when some portions of the reach were very narrow (0.6 m) and shallow (< 0.2 m) (Figure 6.6). Stream widths varied from 0.6 to 7.0 m during the first survey and 0.6 to 4.5 m during the second survey (Tables 6.8 and 6.9).

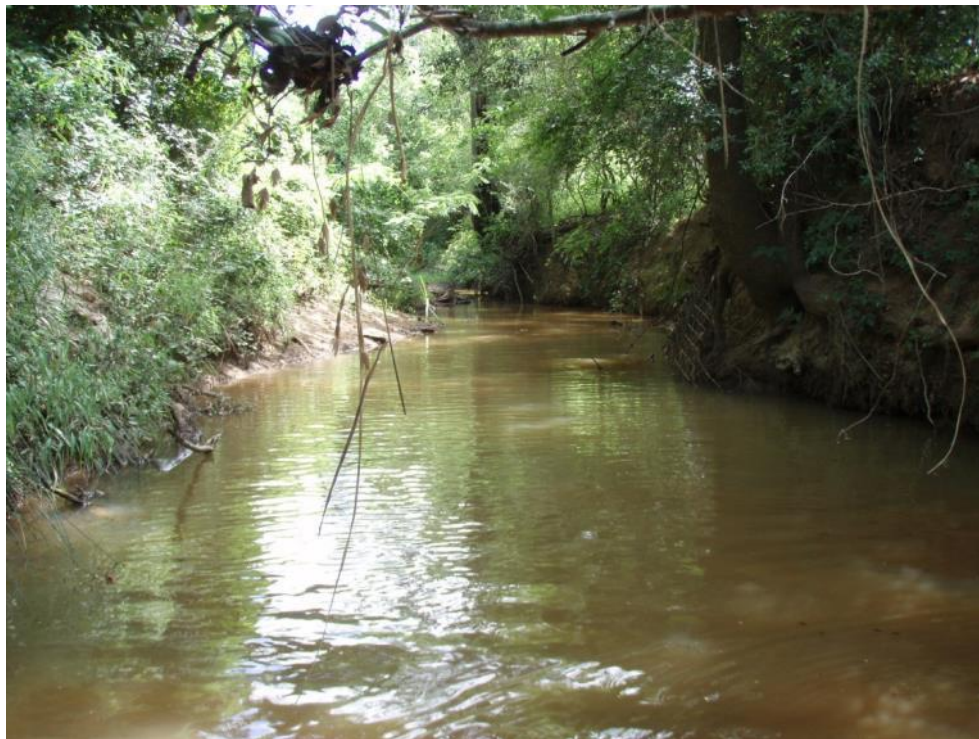
Figure 6.5 Photograph of Pin Oak Creek Site 20385 taken on June 29, 2010, the upstream view of the 150-m transect.

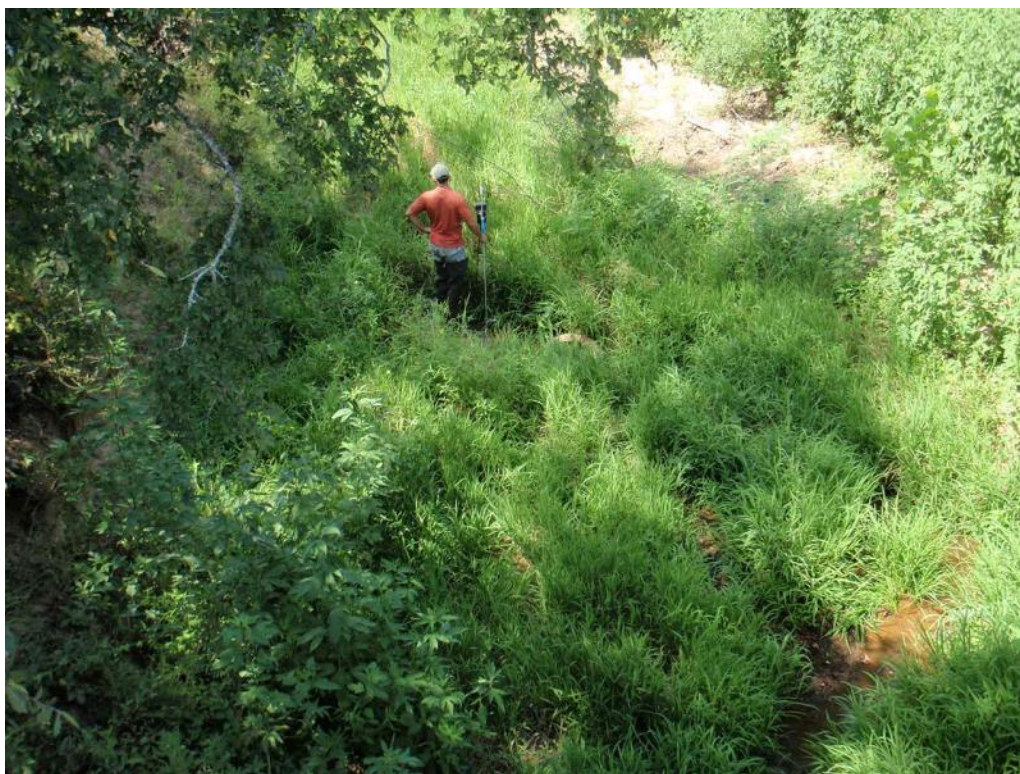
Figure 6.6 Photograph of Pin Oak Creek Site 20385 taken on August 23, 2010, the downstream view of the 0-m transect showing narrow, shallow stream under low-flow conditions. BRA personnel in photograph.

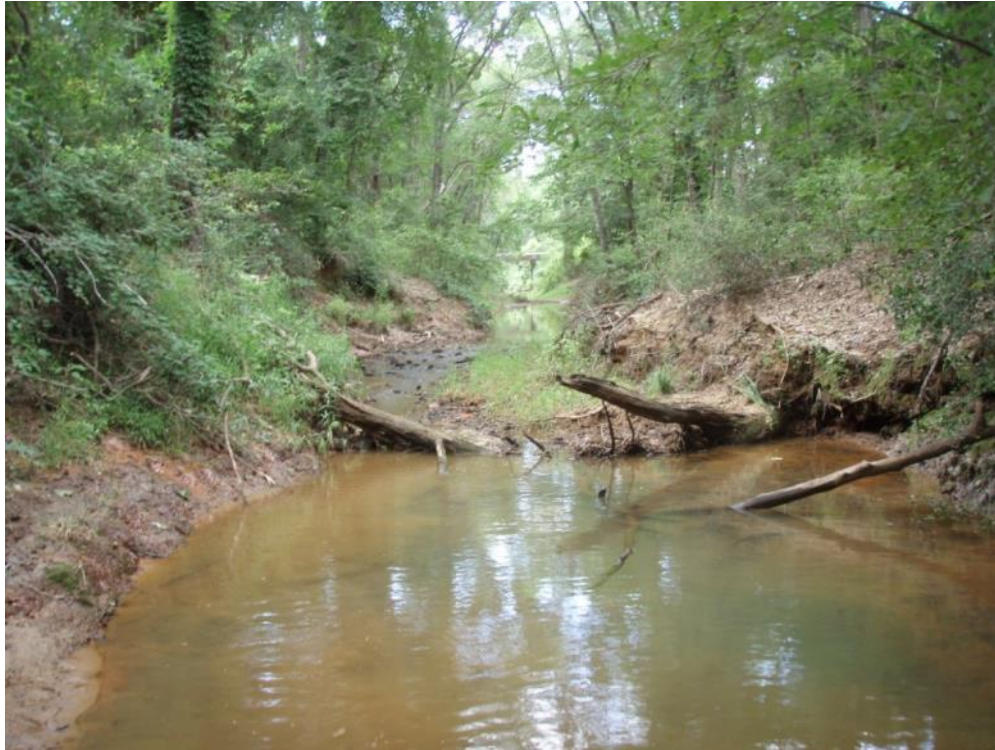
Figure 6.7 Photograph of Pin Oak Creek Site 20563 taken on June 28, 2010, the upstream view of the 150-m transect.

Pin Oak Creek at Site 20563 was visited on June 28 and August 20, 2010. Located east of Hearne, Texas, in Robertson County, this site was accessible from the right-of-way at the FM 391 crossing. The site is located in a forest and shrub dominated corridor (Table 6.6 and Figure 6.7). Stream access was moderately difficult due to steep, muddy banks and occasional dense brush (Figures 6.7 and 6.8).

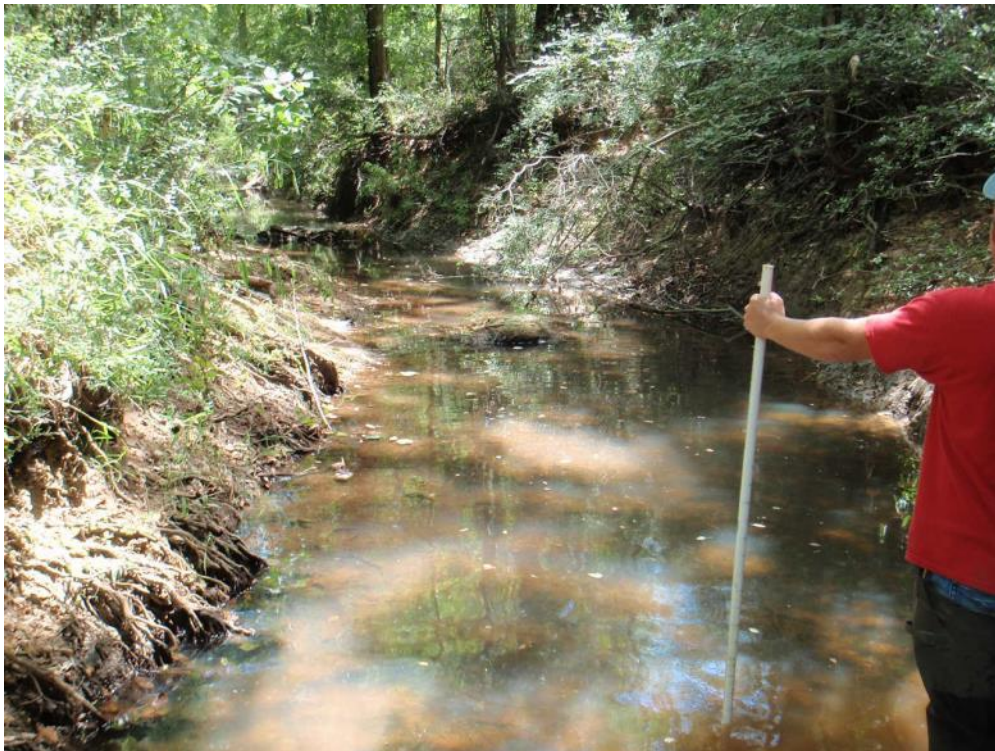
Figure 6.8 Photograph of Pin Oak Creek Site 20563 taken on August 20, 2013, the downstream view of the 300-m transect. BRA personnel in photograph.

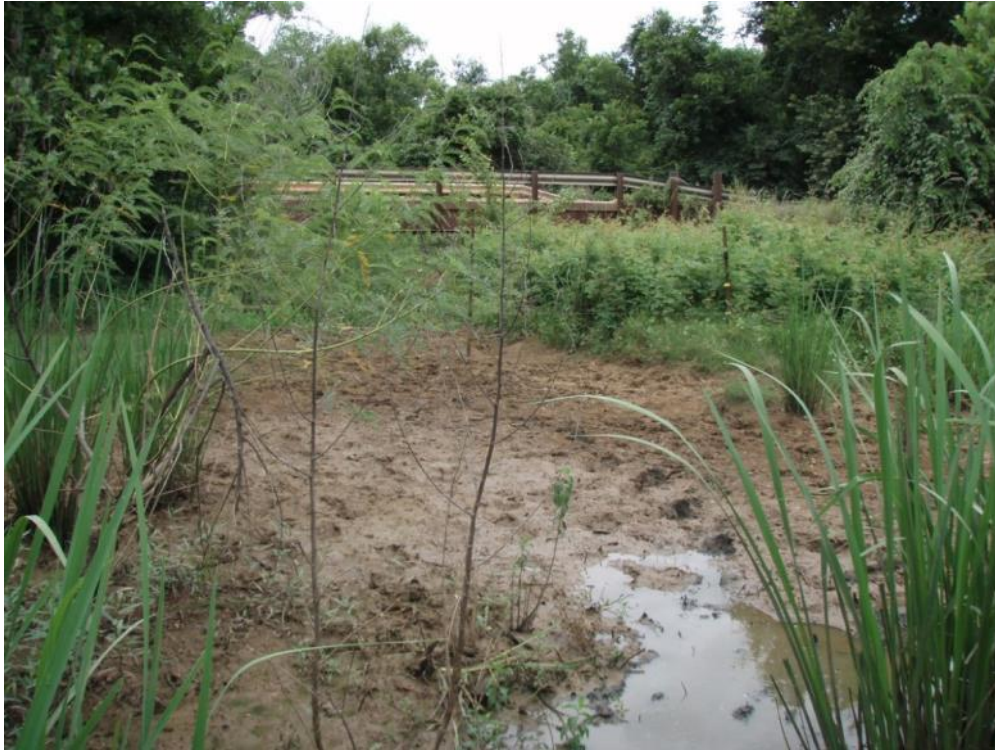
Figure 6.9 Photograph of Pin Oak Creek Site 99910 taken on June 28, 2010, the upstream view of the 30-m transect, including a portion of one pool.

Aesthetic appearance of the water and wildlife observations for the site during each survey are provided in Tables 6.10 and 6.11. In August, a few cows were observed in the creek bed and bovine tracks were common during both surveys (Figures 6.9 and 6.10). No other mammals or vertebrates were observed during either survey. Aquatic vegetation was abundant in the mostly-dry channel during both surveys and terrestrial vegetation as also common during the second survey. Algae was rare in June and absent in August. The water color was brown and often covered in scum when it was present during the first survey. Trash was rare, confined mostly to the bridge area, and was comprised of bottles, cans, and some household garbage. No human presence or signs of recreation were found within the reach.

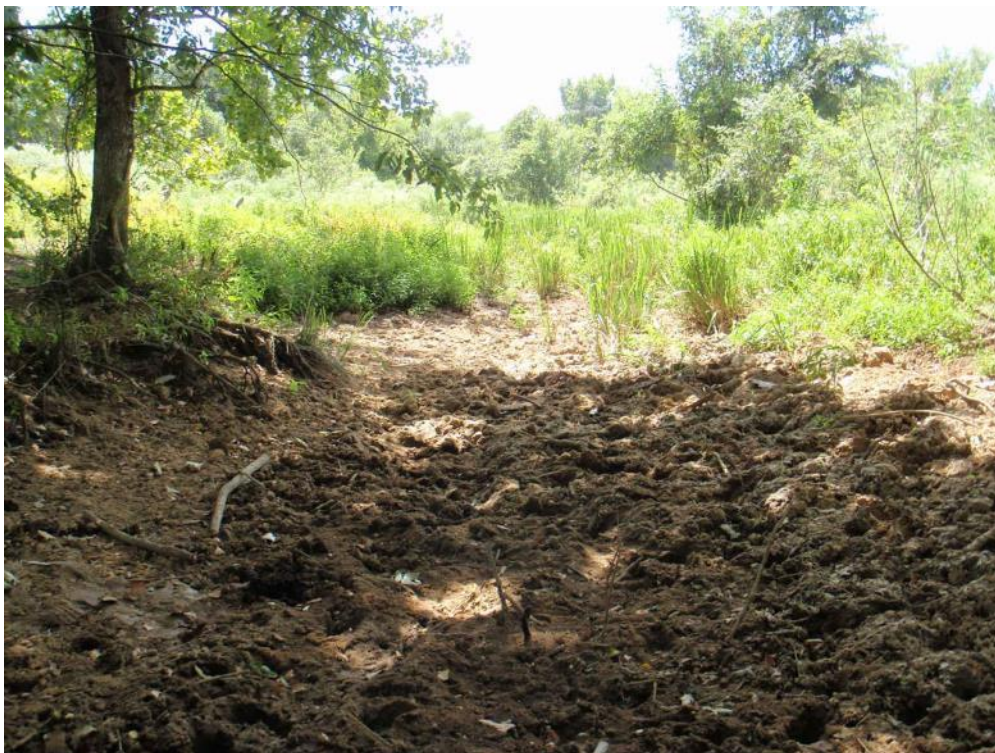
Figure 6.10 Photograph of Pin Oak Creek Site 99910 taken on August 20, 2010, the upstream view of the 150-m transect.

Pin Oak Creek at Site 99910 was visited on June 28 and August 20, 2010. Located northeast of Hearne, Texas, in Robertson County, this site was surrounded on all sides by forest and brush, but was accessible from the right-of-way of Pin Oak Road / CR 229. Access to the stream was easy, except for fences and brush (Figure 6.9). Flow was not observed during the two surveys and the average thalweg depth was 0.12 m. Shallow, stagnant pools were only large enough to measure during the June event (Figure 6.9). These pools were all wadeable ranging 0.06 – 0.45 m deep and 24 – 73 m in length. During the second survey the stream was mostly dry with only a few insignificant muddy puddles (Figure 6.10). No major obstructions in the stream channel were observed.

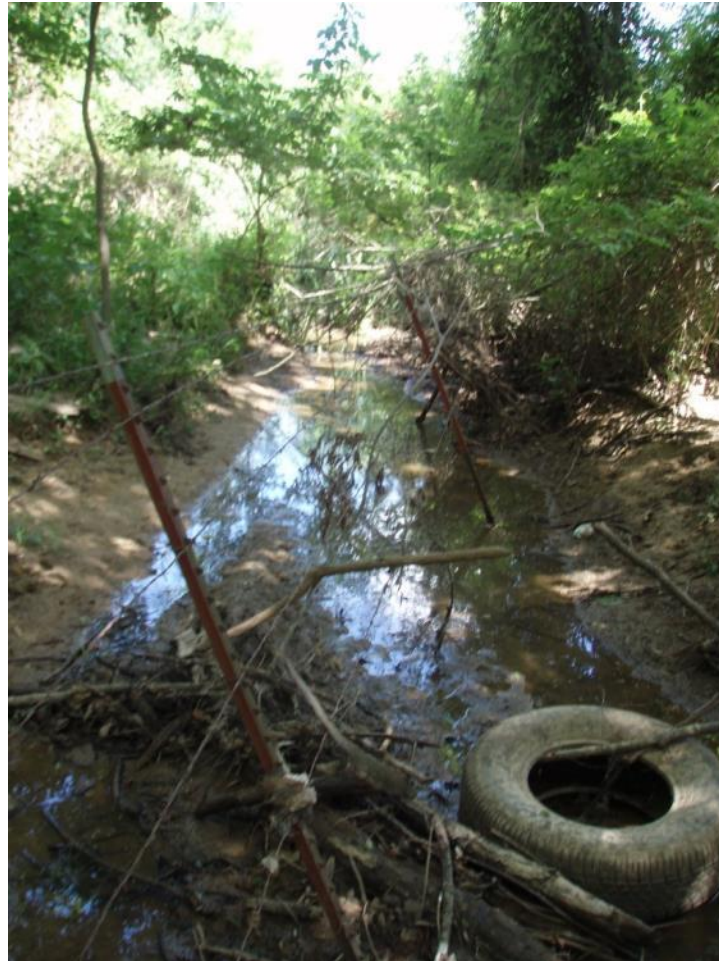
Figure 6.11 Photograph of Pin Oak Creek Site 99911 taken on June 28, 2010, the downstream view between the 150-m and 300-m transects showing fence crossing stream channel.

Pin Oak Creek at Site 99911 was visited on June 28 and August 20, 2010. Located northeast of Hearne, Texas, in Robertson County, this site was accessible from Pin Oak Road / CR 329. The 300-m reach downstream of the road crossing runs through private land and had several fences (Figure 6.11) and posted no-trespassing signs crossing the creek. The survey reach originates from a culvert under Pin Oak Road / CR 329 (Figure 6.12) that empties into a dammed pond and flows through a forest and shrub-dominated corridor. Figures 6.12 and 6.13 depict the appearance of the site during each of the surveys.

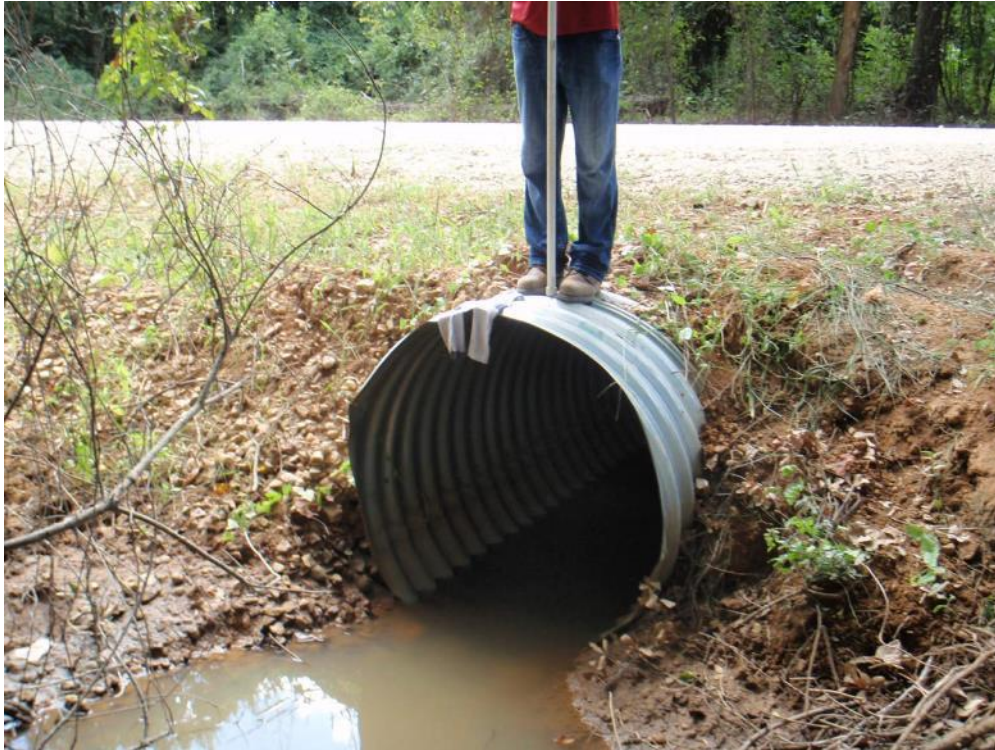
Figure 6.12 Photograph of Pin Oak Creek Site 99911 taken on August 20, 2010, the upstream view at the 0-m transect. BRA personnel in photograph.

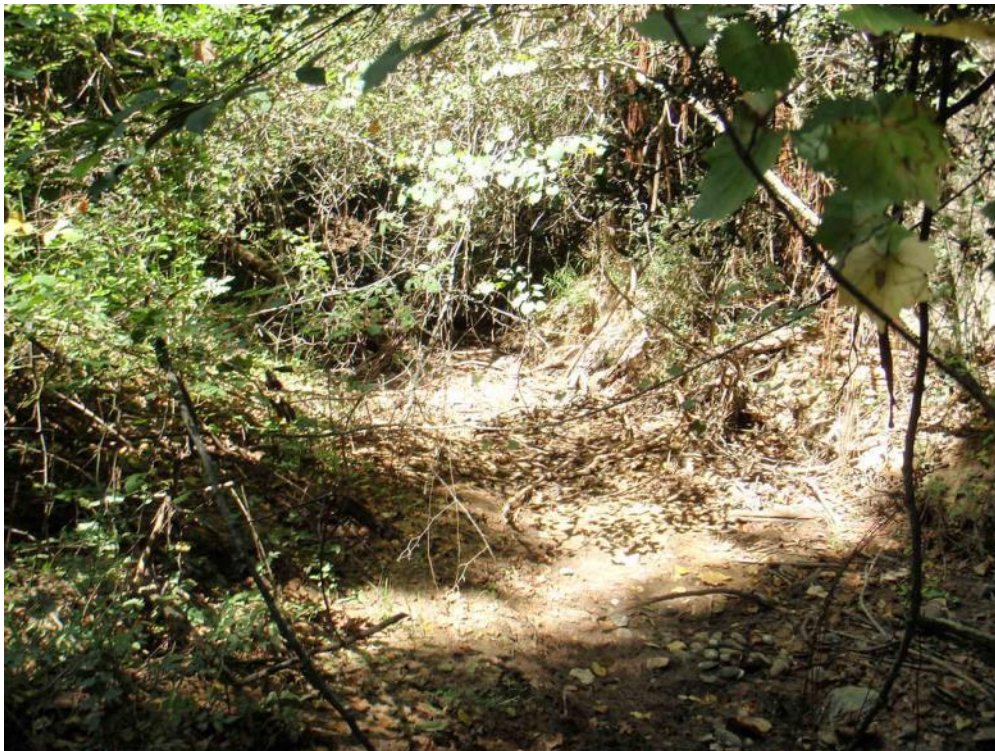
Figure 6.13 Photograph of Pin Oak Creek Site 99911 taken on August 20, 2010, the downstream view of the 30-m transect.

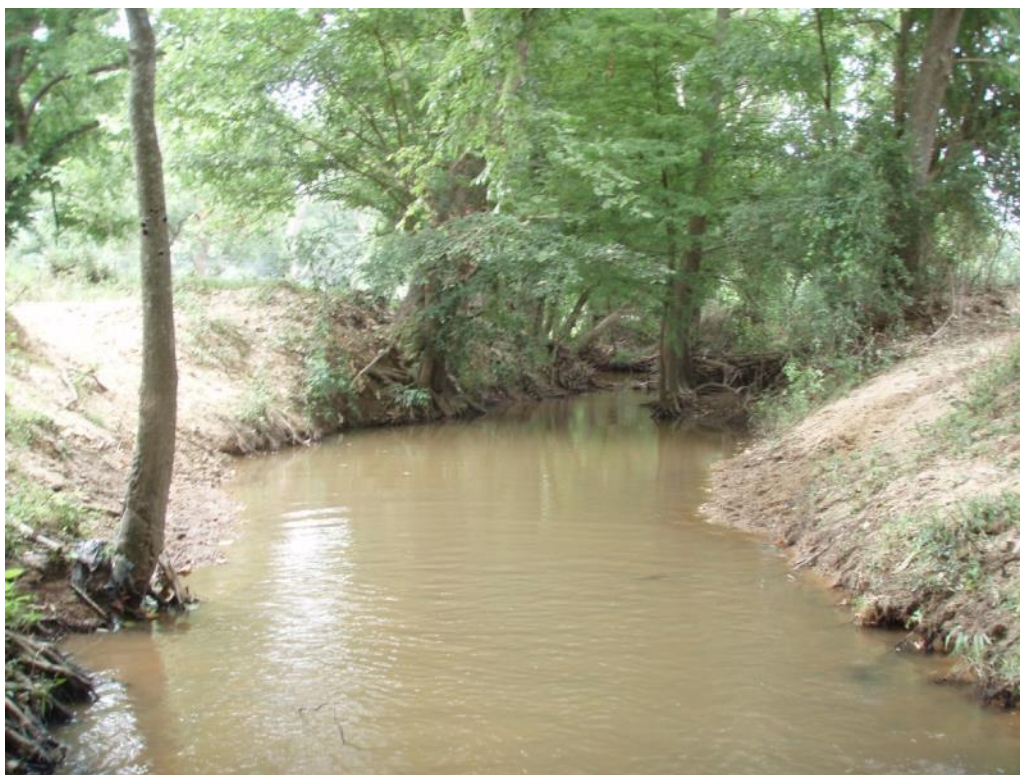
Figure 7.2 Photograph of Spring Creek Site 99912 taken on June 30, 2010, the upstream view of the 150-m transect.

Spring Creek at Site 99912 was visited on June 30 and August 20, 2013. Located southeast of Hearne, Texas, in Robertson County, this site was accessible from the right-of-way of Old Hearne Road but was located primarily in a fenced private pasture. Both banks were vegetated with trees and shrubs usually only 10 - 20 m back from the stream with pasture dominating the area beyond the immediate riparian corridor. Access to the stream was easy. Figures 7.2 and 7.3 depict the general appearance of the site and water quality during each of the surveys.

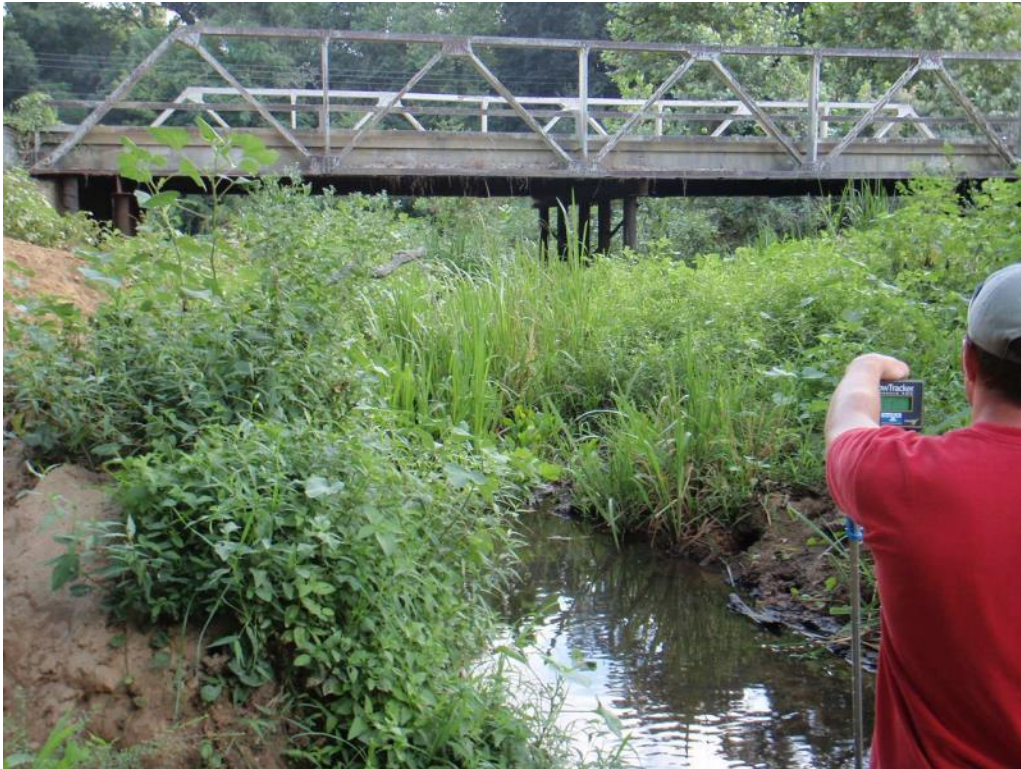
Figure 7.3 Photograph of Spring Creek Site 99912 taken on August 20, 2010, the upstream view of the 300-m transect. BRA personnel in photograph.

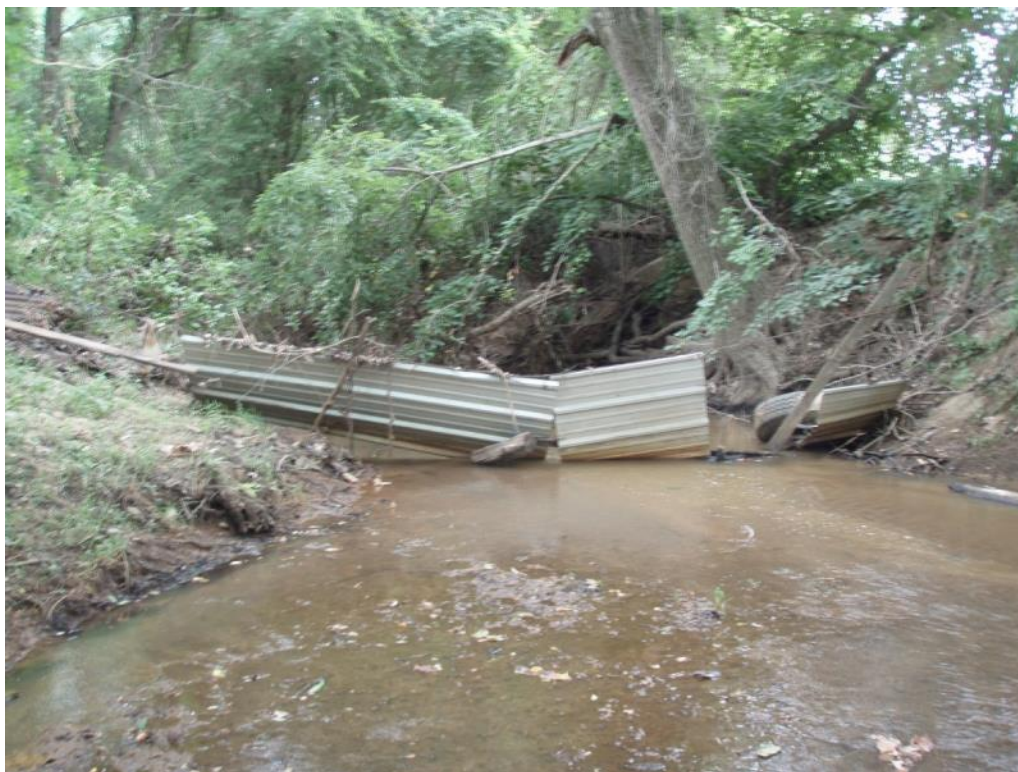
Figure 7.4 Photograph of Spring Creek Site 99912 taken on June 30, 2010, the downstream view of the 150-m transect.

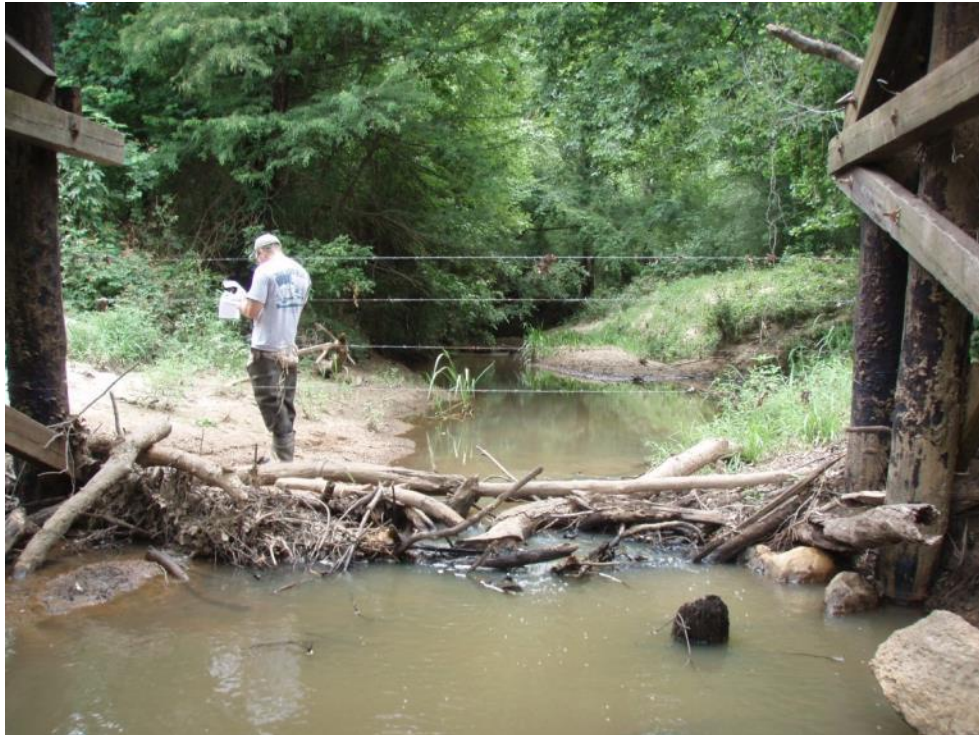
Figure 7.5 Photograph of Spring Creek Site 16394 taken on June 30, 2010, the upstream view of the 30-m transect. BRA personnel in photograph.

Spring Creek at Site 16394 was visited on June 30 and August 18, 2010. Located southeast of Hearne, Texas, in Robertson County, this site was accessible from the right-of-way of SH 6 / US 190. Public access was not difficult except for a barbed-wire fence on the upstream side of the bridge (Table 7.7). The majority of the 300-m reach was on pastured private land with a forested riparian of approximately 0 – 20 m. Banks had mostly gentle slopes throughout the reach, but a few were more steep and treacherous. Figures 7.5 and 7.6 depict the appearance of the site during each of the surveys.

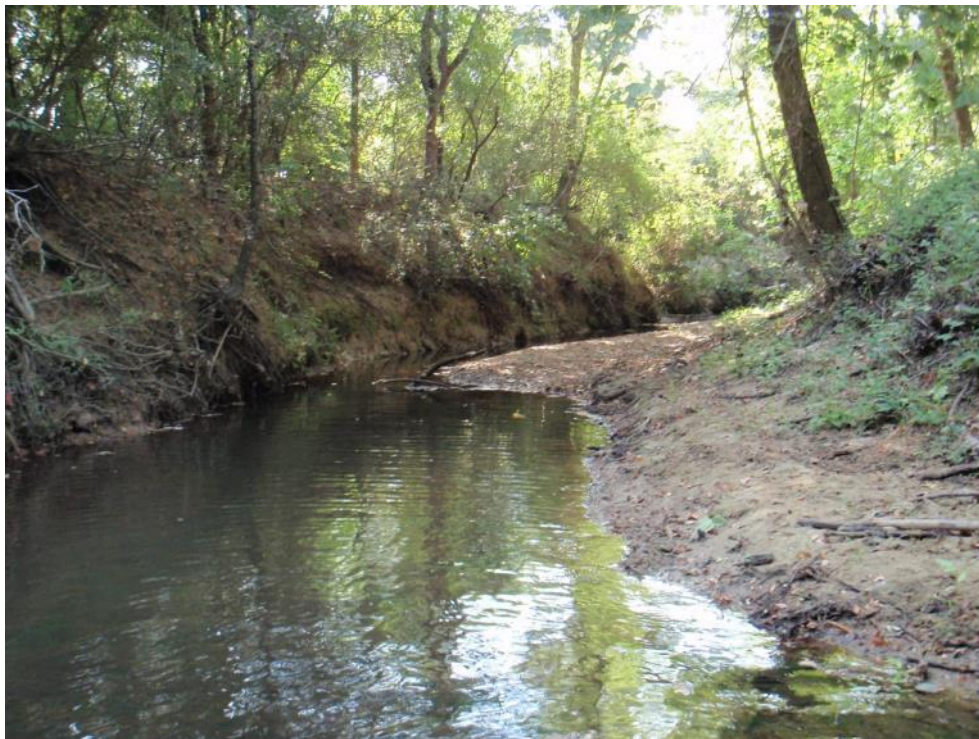
Figure 7.6 Photograph of Spring Creek Site 20385 taken on June 30, 2010, the downstream view of the 300-m transect.

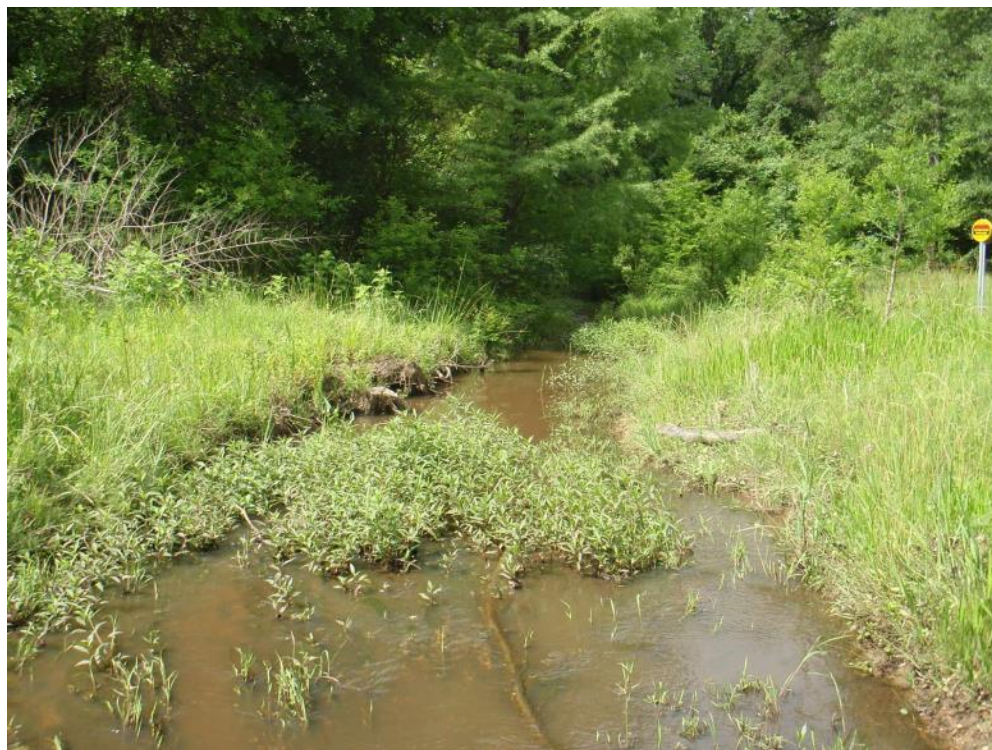
Figure 7.7 Photograph of Spring Creek Site 20564 taken on May 21, 2010, the downstream view of the 30-m transect.

Spring Creek at Site 20564 was visited on May 21 and August 12, 2010. Located southeast of Hearne, Texas, in Robertson County, this site was accessible from the right-of-way at the Jack Rabbit Lane crossing. The site is located in a shrub and pasture-dominated corridor with a wooded riparian zone containing many bald cypress trees (Table 7.6 and Figure 7.7). The knees of the bald cypress might be considered obstructions to boating and some other types of recreation during lower flow conditions. Stream access was moderately easy due to gentle slopes but the private property on which most of the 300-m reach was located, was fenced on both sides of the Jack Rabbit crossing. Signs of upwelling sands and springs were present (Figure 7.8) and the reach was prone to long-lasting seeping after rains leading to marshy conditions. Figures 7.7 and 7.9 depict the general appearance of the site during each of the surveys.

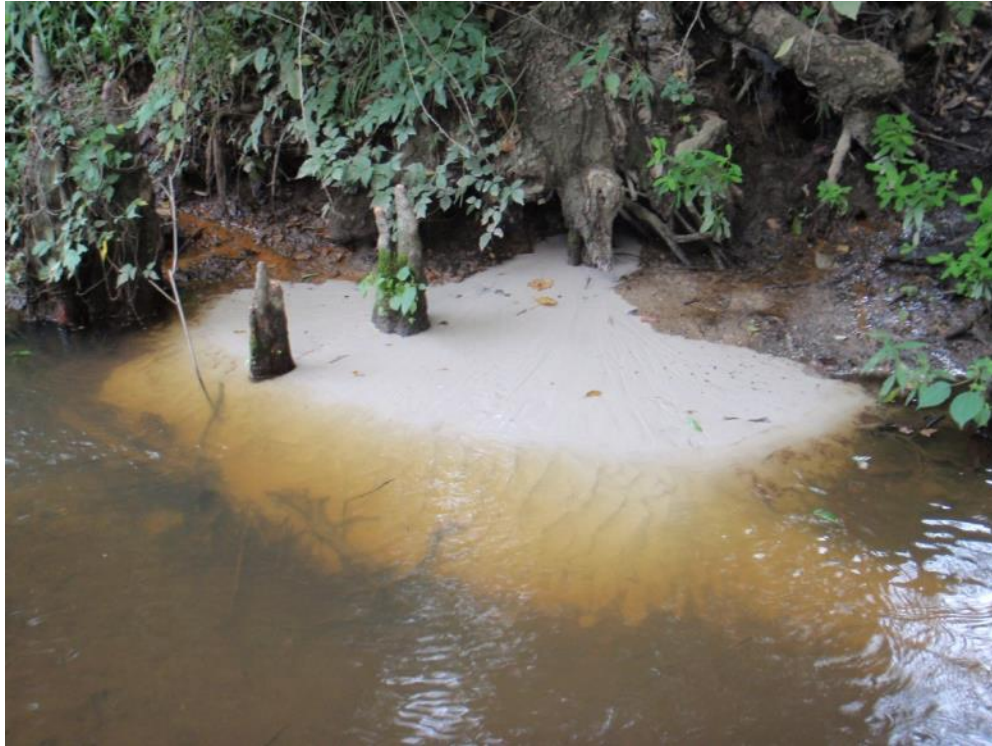
Figure 7.8 Photograph of sandy upwelling on Spring Creek Site 20564 taken on August 12, 2010.

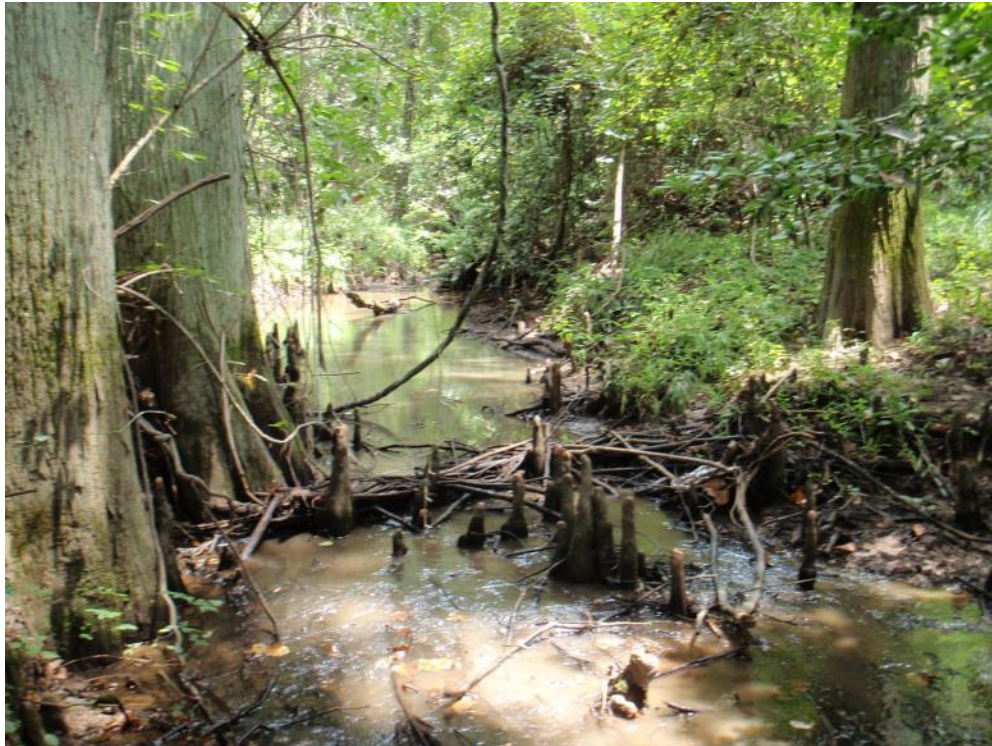
Figure 7.9 Photograph of Spring Creek Site 20564 taken on August 12, 2010, the upstream view of the 150-m transect.

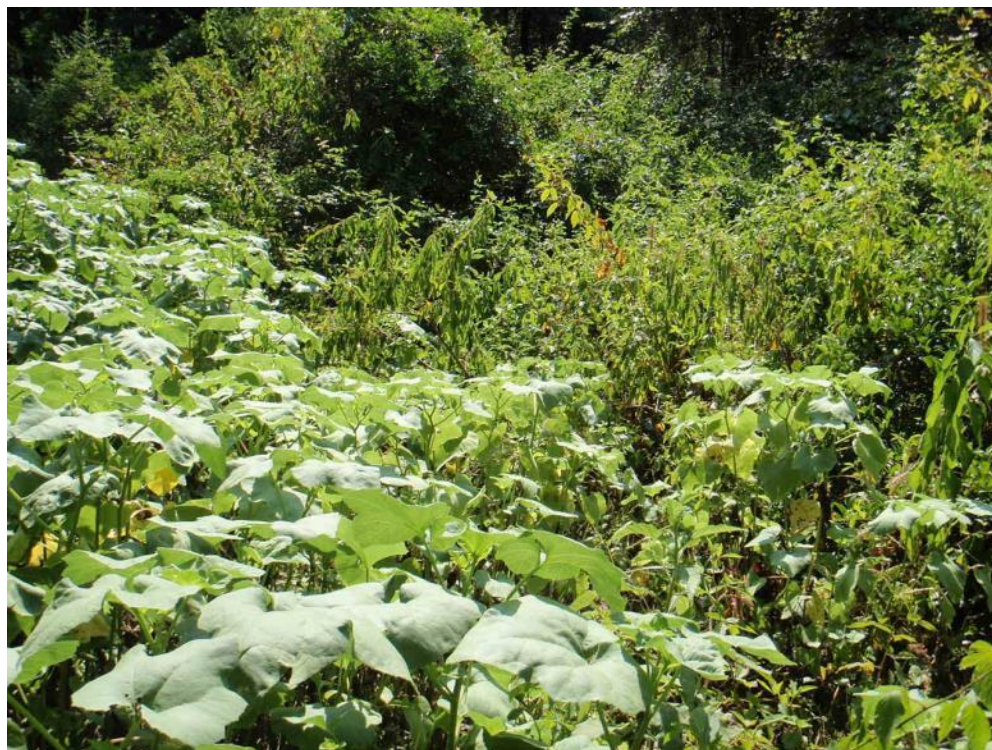
Figure 7.10 Photograph of dense brush at Spring Creek Site 99913 taken on August 18, 2010, the downstream view of the 0-m transect.

Spring Creek at Site 99913 was visited on August 10 and August 18, 2010. Located east of Hearne, Texas, in Robertson County, this site was accessible from private property near the Arrow Moon Road crossing of Spring Creek. In addition to a locked gate, extremely dense brush and thorny vines made access to the stream channel difficult. No water was observed during the two surveys. If water were present, the 300-m reach would be wadeable with exposed roots and a few felled trees as the only significant obstacles. Figures 7.10 and 7.11 depict the general appearance of the site during each of the surveys.

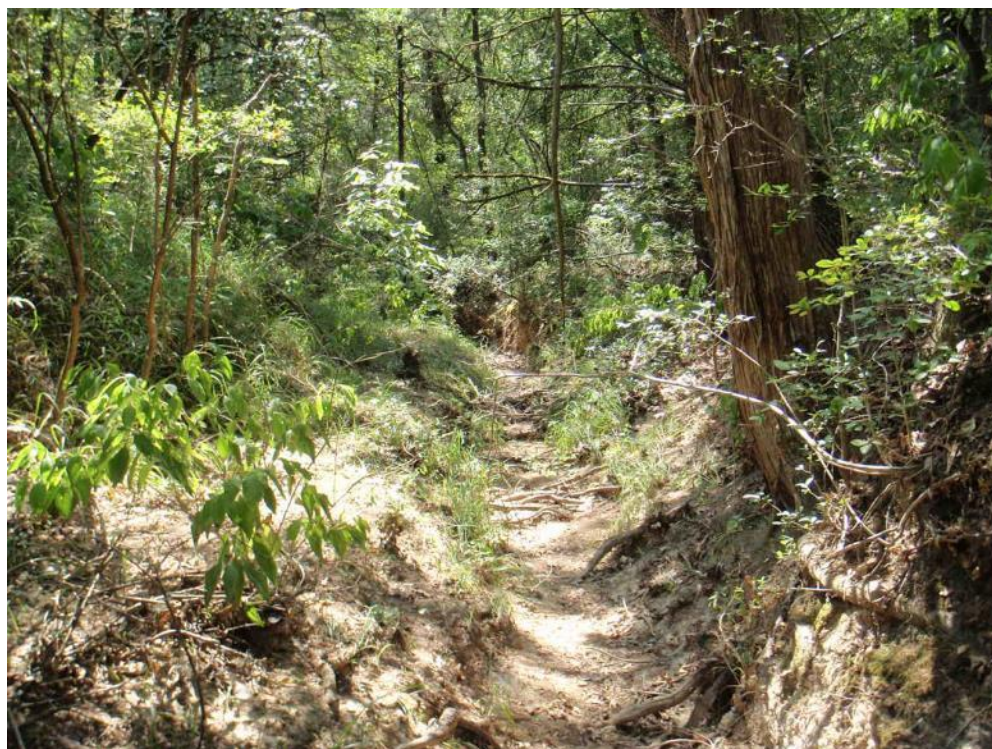
Figure 7.11 Photograph of Spring Creek Site 99913 taken on August 18, 2010, the upstream view of the 150-m transect.
